**ALAMEDA POINT
LANDFILL #2**

**REMOVAL OF
BURIED RADIOACTIVE DEVICES
AND ADJACENT CONTAMINATED SOIL**

SUMMARY REPORT

September 8, 1999

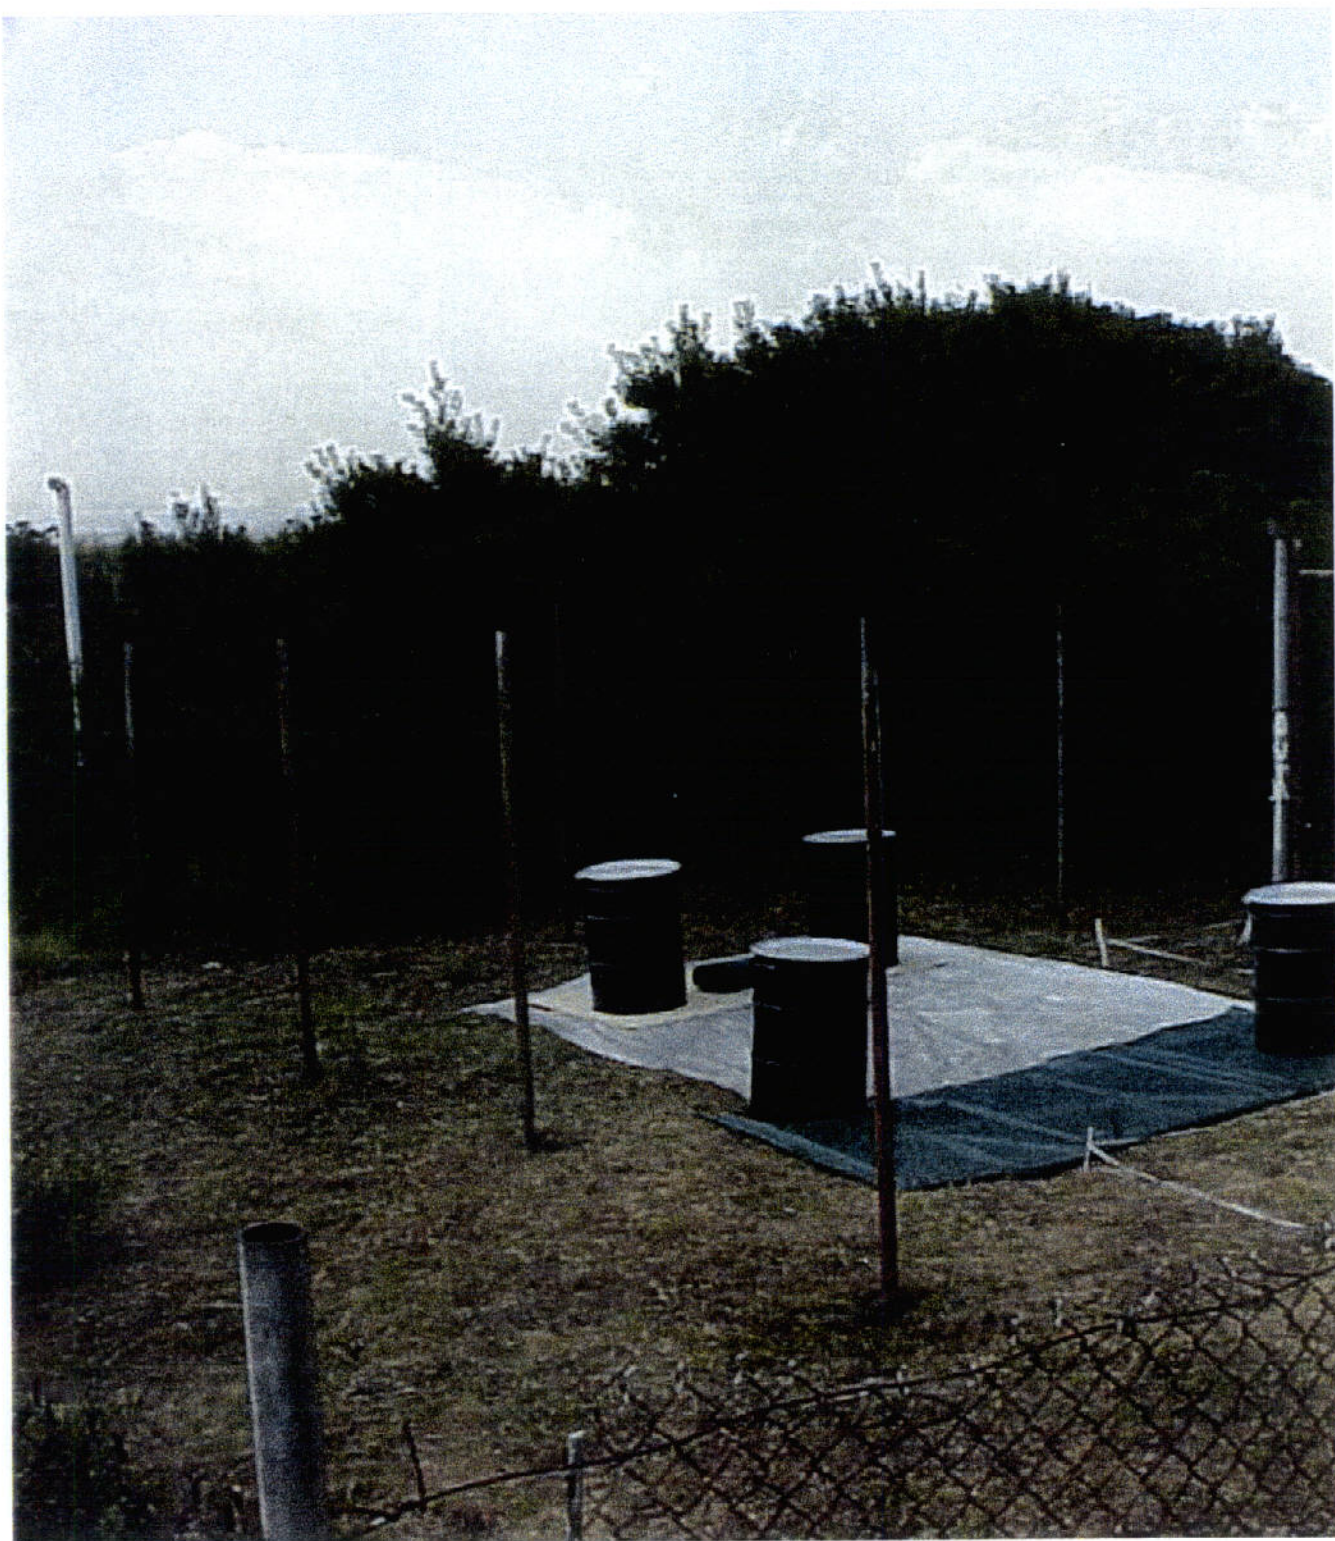
**ALAMEDA POINT LANDFILL #2
"RADSHACK" SITE
(VIEWED FROM PERIMETER ROAD)**

Remediation operations at the "radshack" site involved removal of 10 steel perimeter posts with concrete footings and hand digging of 10 individual sites within and adjacent to the perimeter. Only 2 discrete items (see Enclosure (1) items 35 and 44) were unearthed at the site, however, a total of eight 55 gal. drums of soil, rock and concrete were required to be removed in order to achieve ground surface levels of <20 KCPM. See Enclosures (3), (4) and (5) for details regarding before and after cleanup levels.

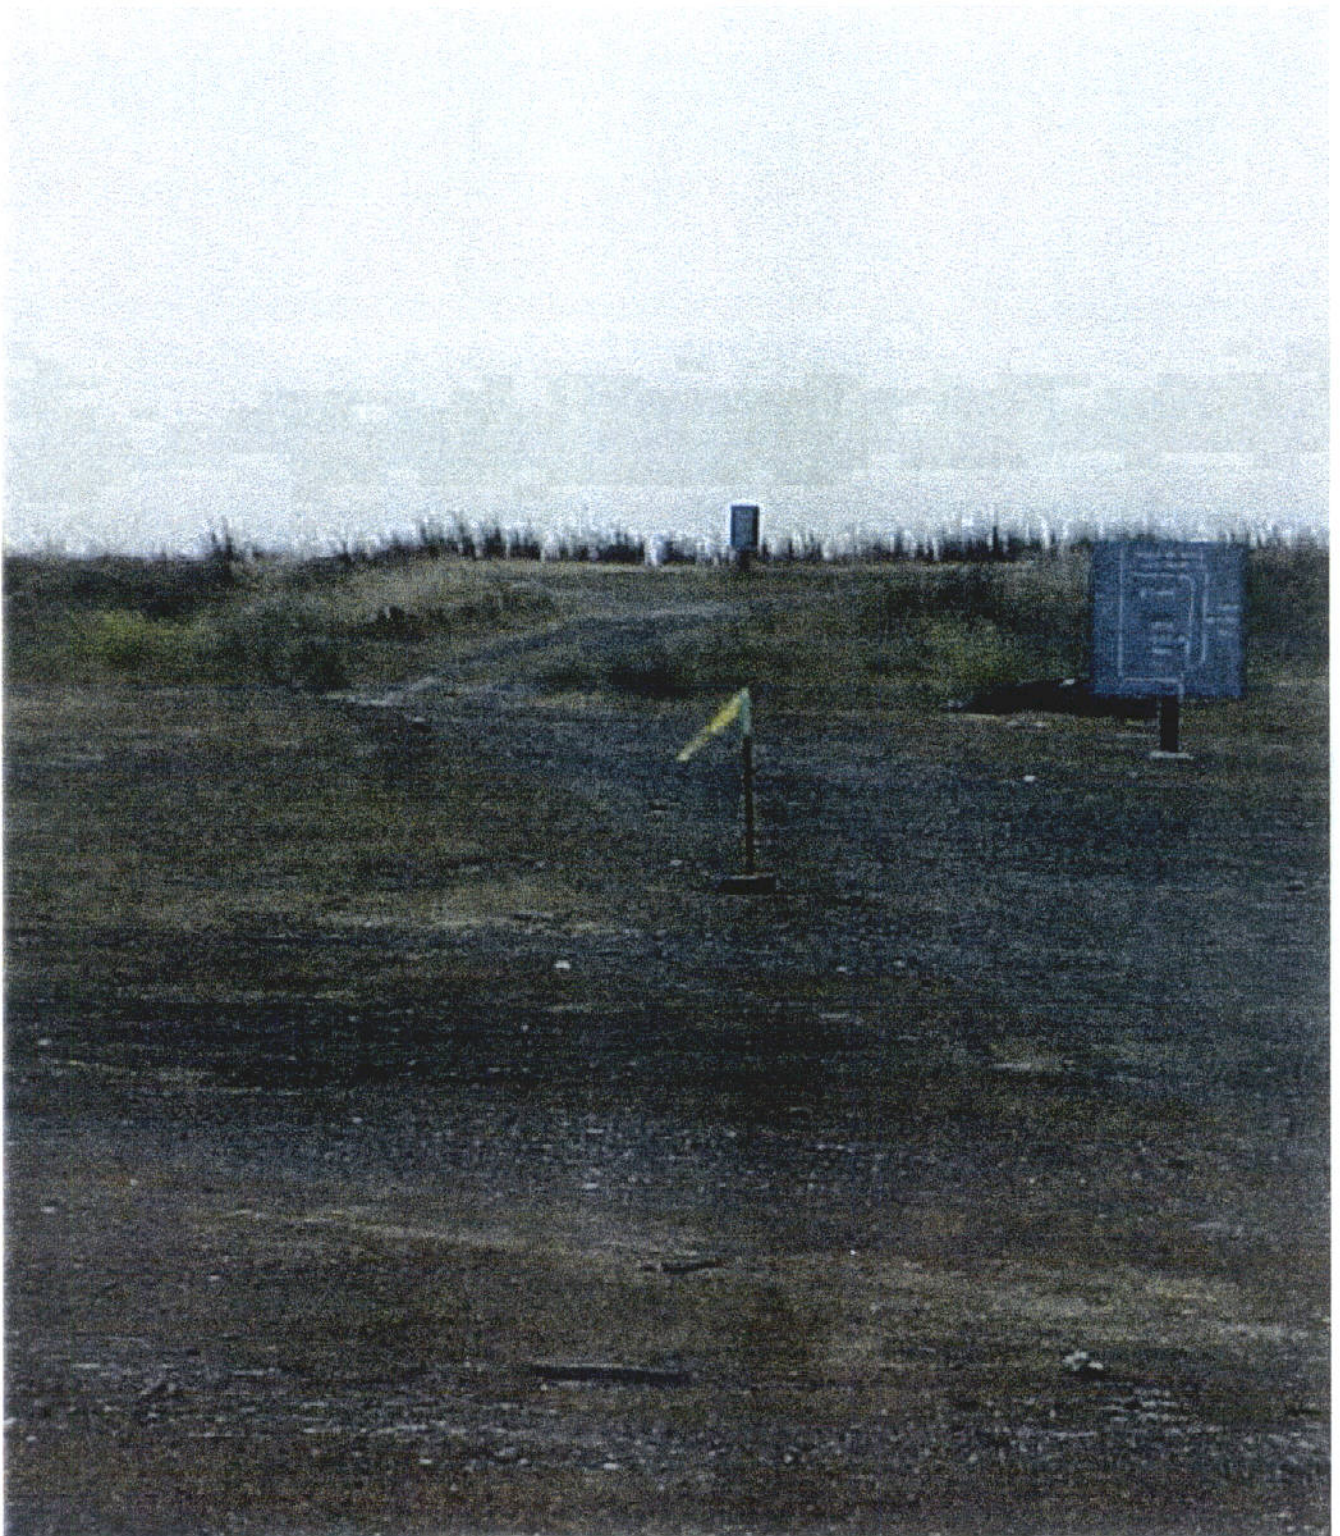
**ALAMEDA POINT LANDFILL #2
ANOMALY REMOVAL SITE #21
(ON ROAD INSIDE NORTHEAST ACCESS GATE)**

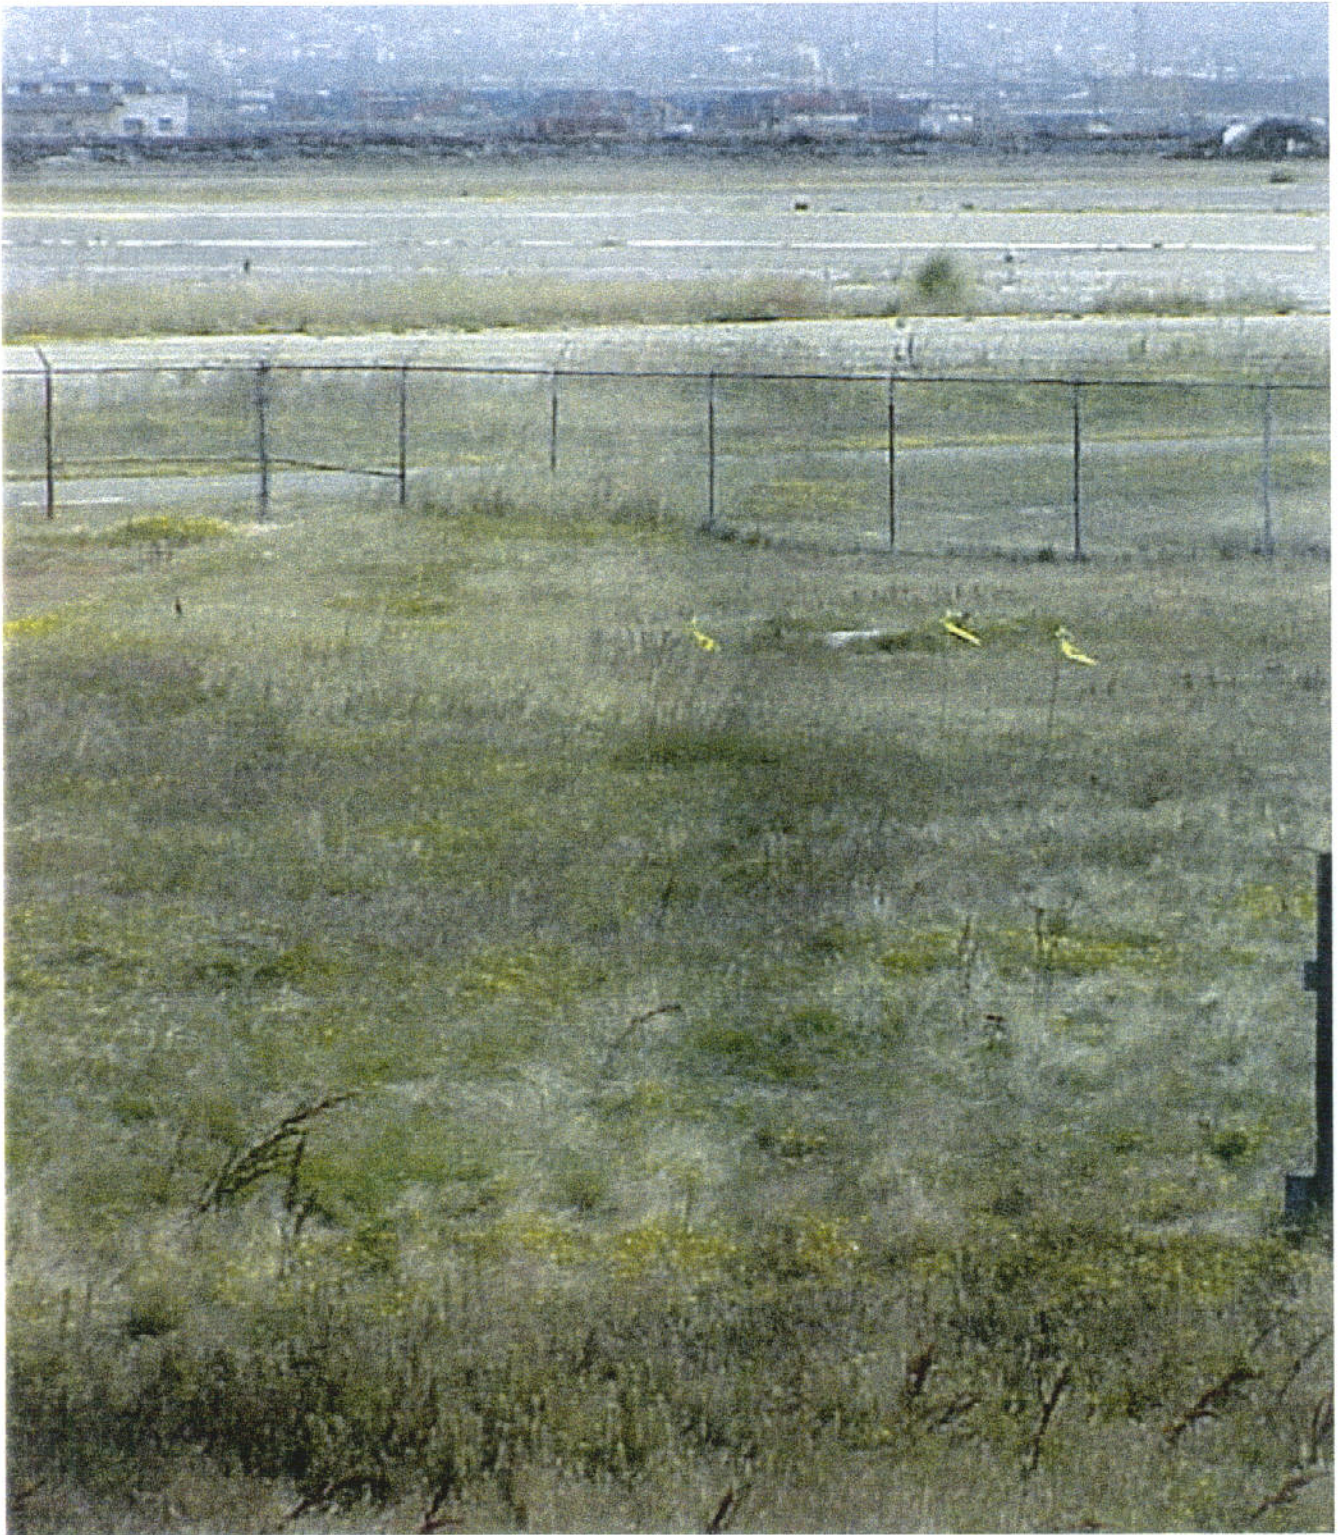
**ALAMEDA POINT LANDFILL #2
ANOMALY REMOVAL SITES #23, 24 & 25
(INSIDE FENCE EAST OF BUNKER M354)**

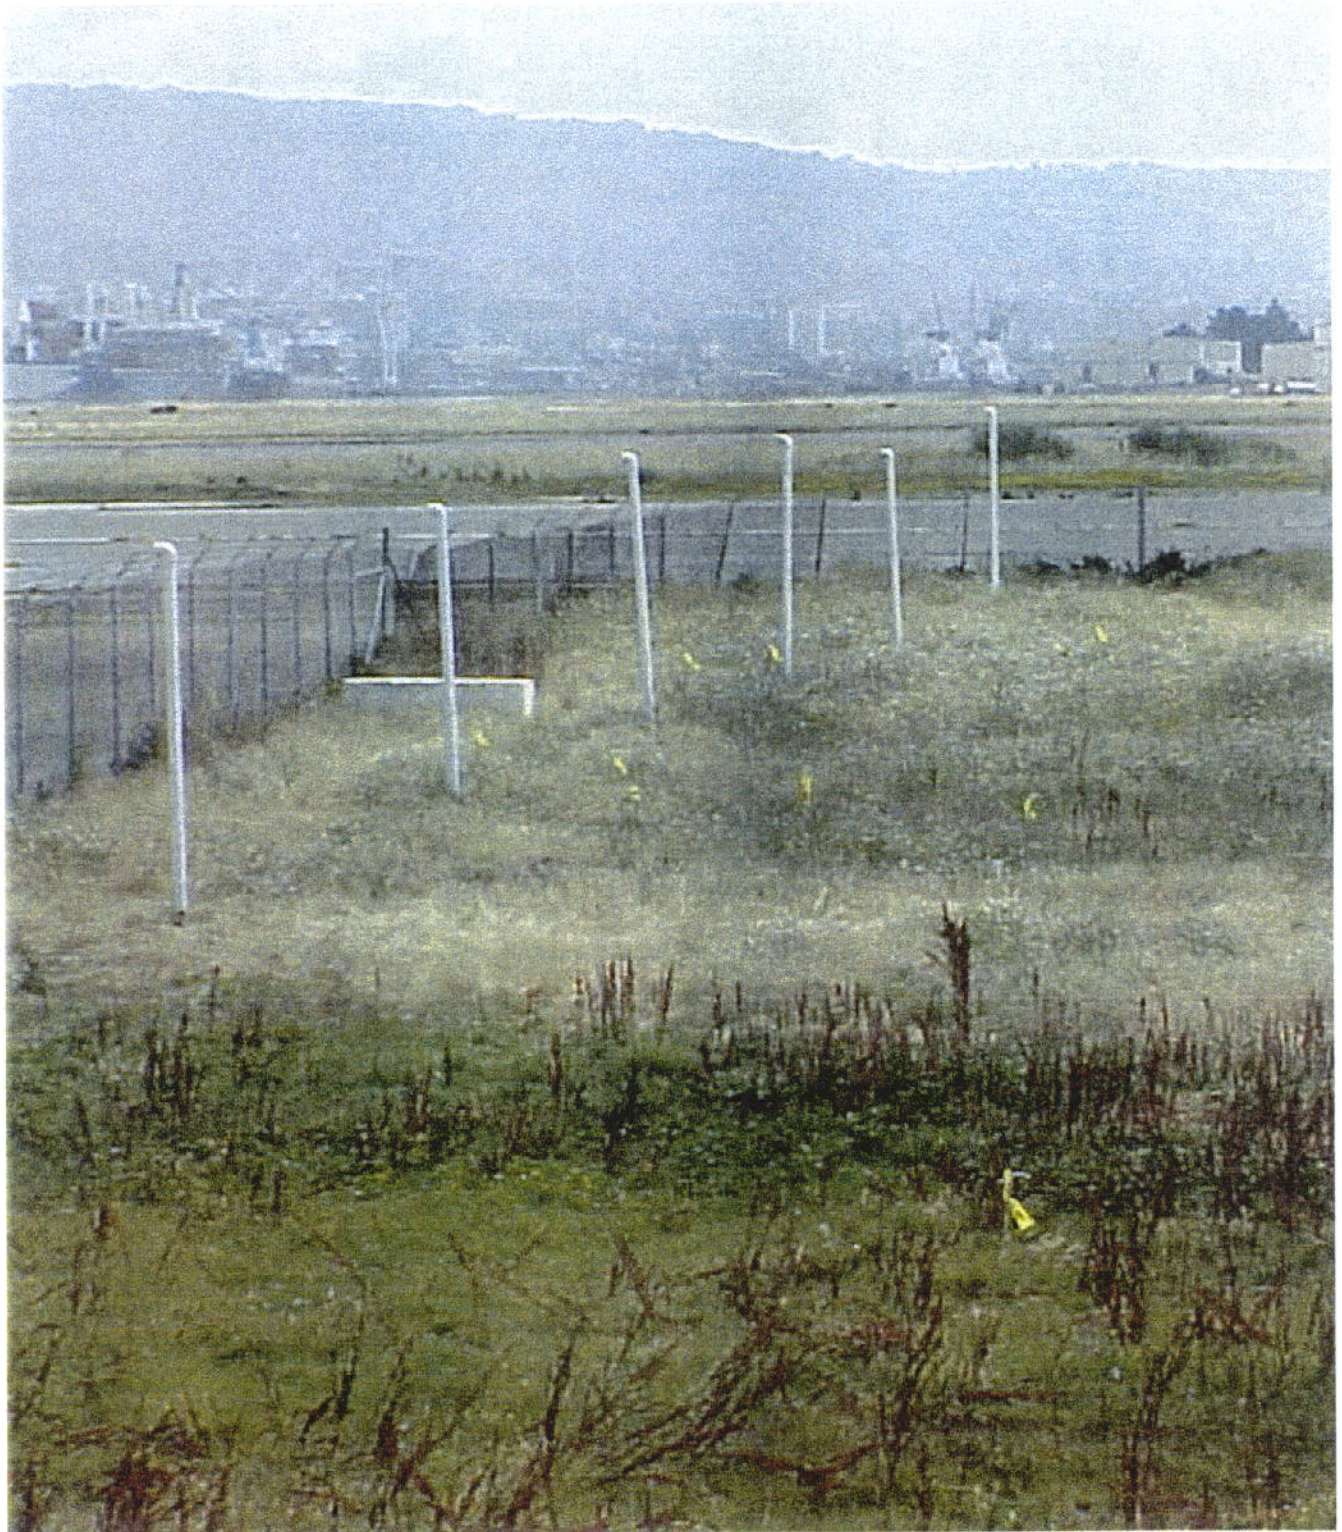
**ALAMEDA POINT LANDFILL #2
(YELLOW FLAGS INDICATE SITES SOUTHEAST OF BUNKER
M354 WHERE MOST RADIUM BUTTONS WERE FOUND)**

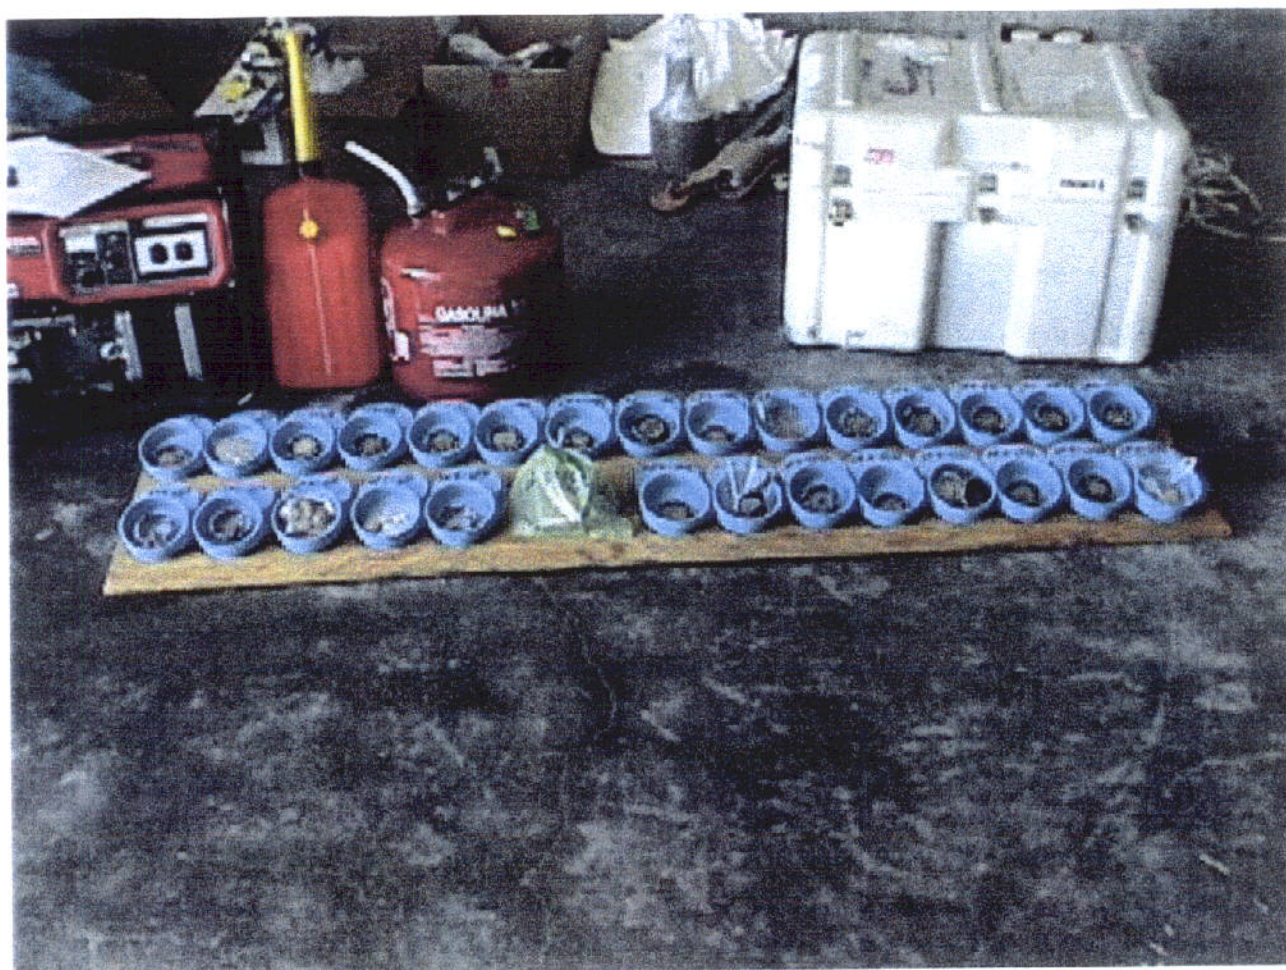
**ALAMEDA POINT LANDFILL #2
COLLECTION OF DISCRETE ITEMS
TEMPORARILY STORED IN BUNKER M353)**

A total of fifteen 55 gal. drums of contaminated soil removal materials and all discrete items removed from the 50 individual sites listed in Enclosure (1) were transported from temporary storage at Bunker M353 to Building 5 for characterization sampling by "New World Technologies" in preparation for disposal. Bunker M353 was surveyed and swipe sampled clean after all material was removed. All anomaly removal site and "radshack" site excavations have been refilled with clean soil (ie., isotopic analysis results of fill material indicated 1.005 pCi / gram radium) and all resolved site markers have been removed. See Enclosure (6) photos provided for information.

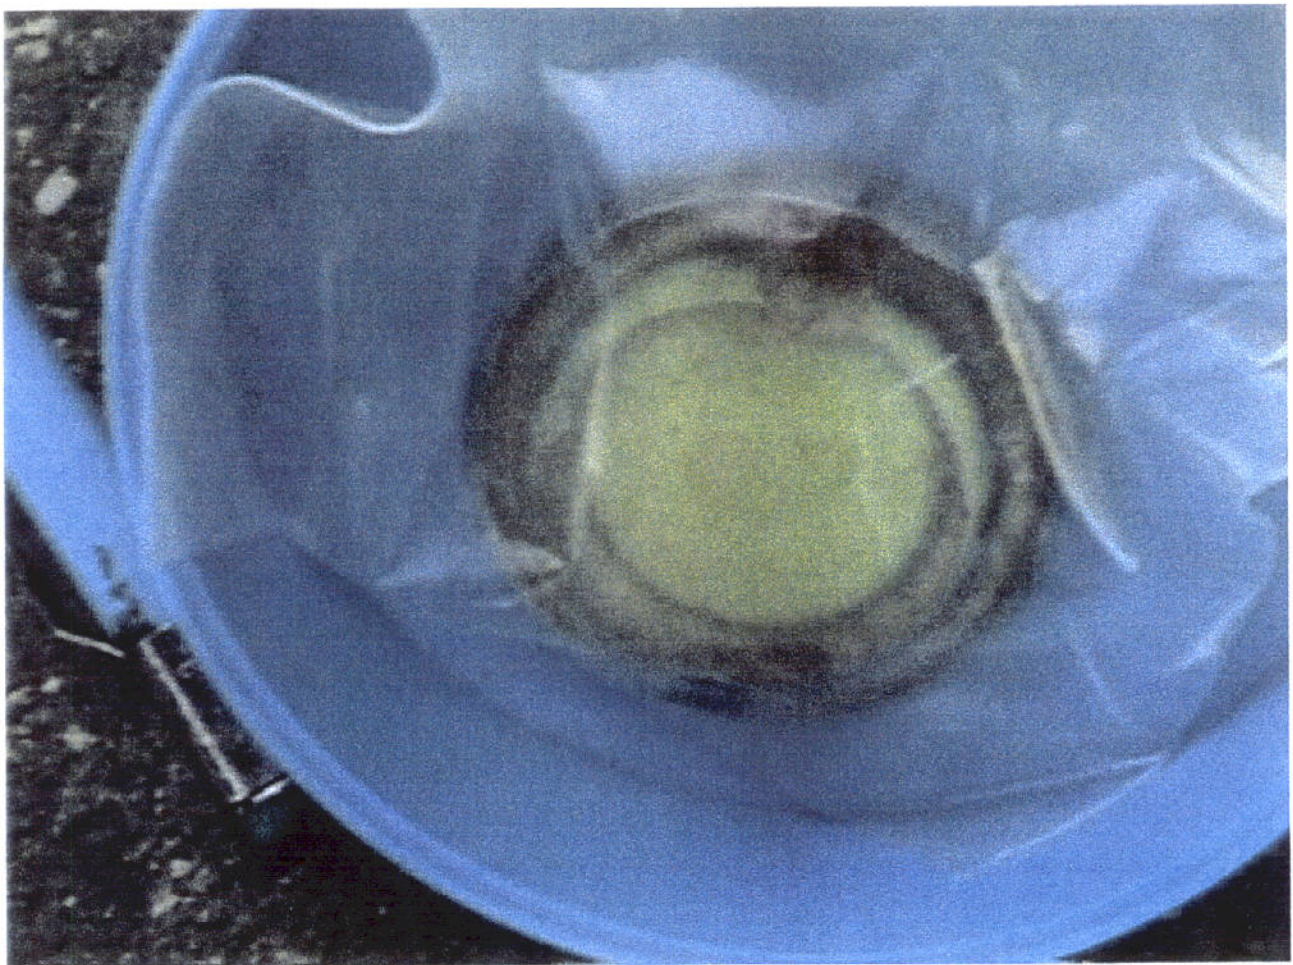
**ALAMEDA POINT LANDFILL #2
FRONTSIDE OF Sr-90 BUTTON
(FROM ANOMALY REMOVAL SITE #29 OR 49)**

48	13 / 7	1472564.8	474323.74	green glass chunk 1/2" diameter. @ 2"	@ fenceline
49	160 / 13	1472949.8	474005.74	strontium button @ 3" (same as 29)	
50	42 / 7	1472802.8	474046.74	big "T"-handle snap switch @ 12"	weighs ~10#'s 800 KCPM on contact

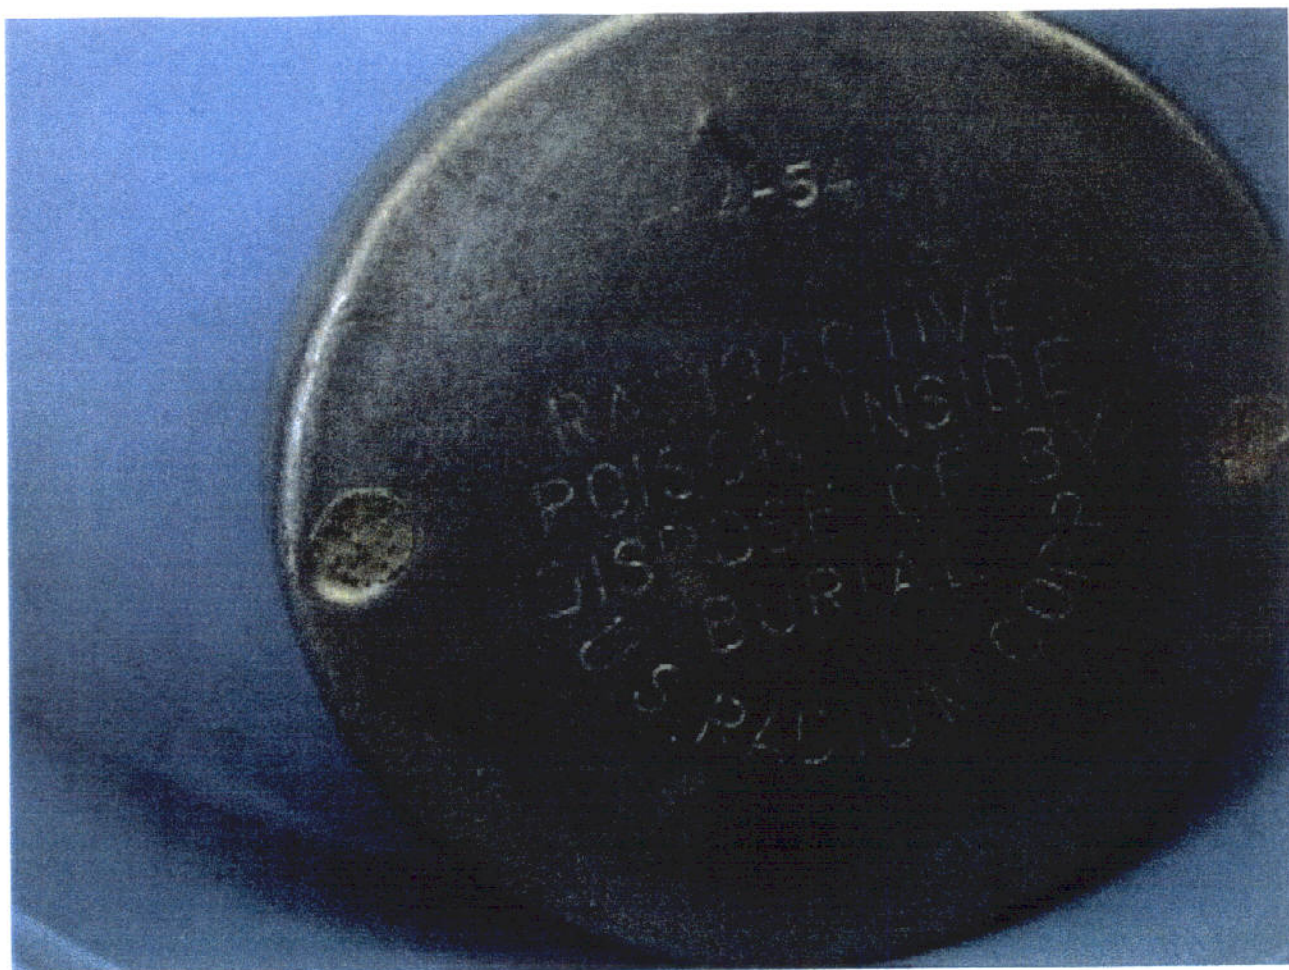
**ALAMEDA POINT LANDFILL #2
BACKSIDE OF Sr-90 BUTTON
(FROM ANOMALY REMOVAL SITE #29 OR 49)**

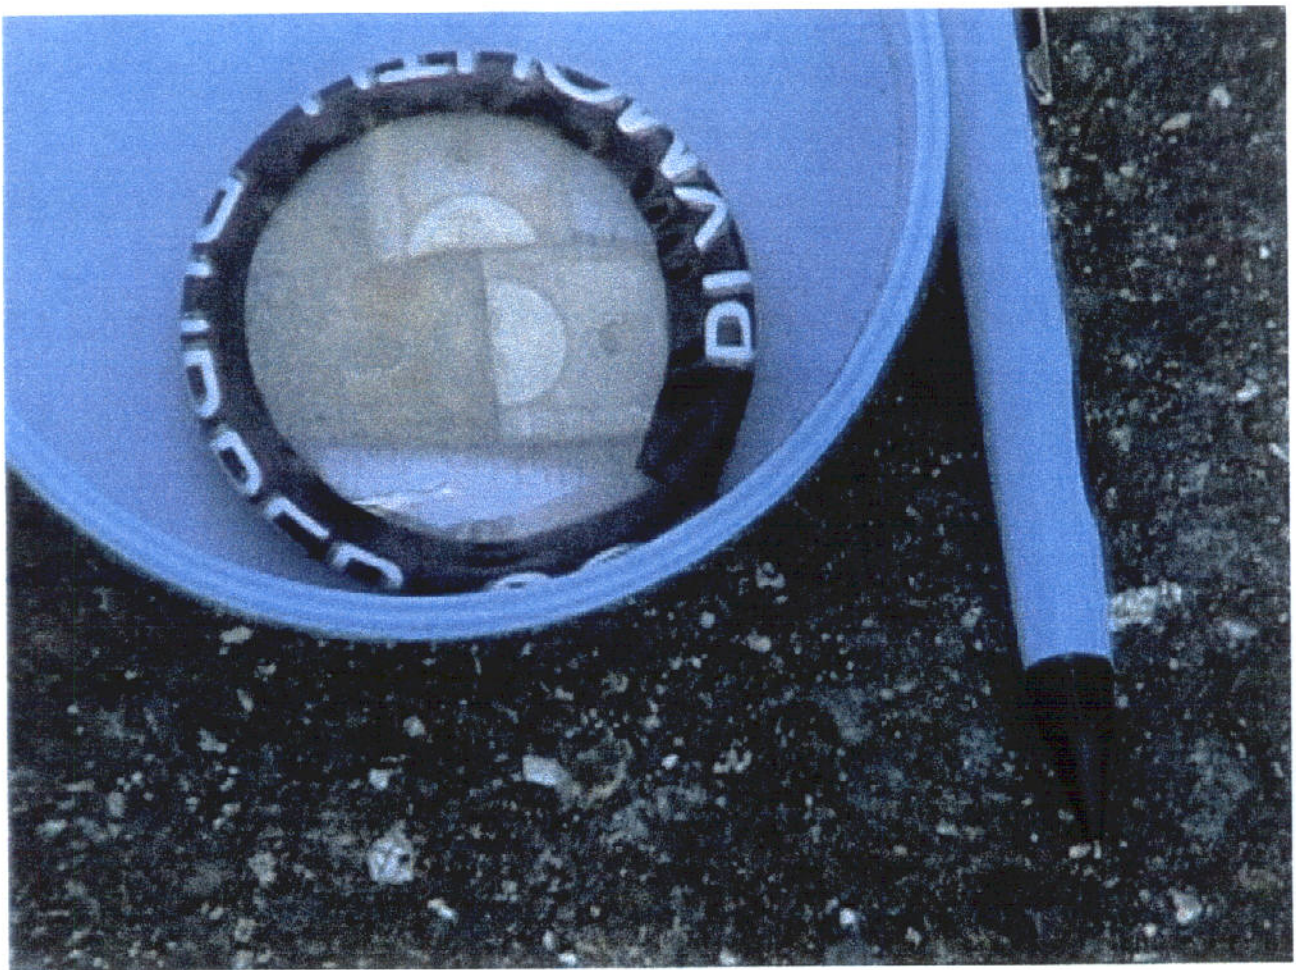
**ALAMEDA POINT LANDFILL #2
PLASTIC "GLOW DOT"
(FROM ANOMALY REMOVAL SITE #15)**

SITE I.D.	GROUND SURFACE KCPM *	"X" AXIS COORDINATE (State Plane Coordinates)	"Y" AXIS COORDINATE (State Plane Coordinates)	ITEM DESCRIPTION & ~ DEPTH	REMARKS
1	136 / 8	1472736.8	473903.74	radium button @ 10"	
2	50 / 8	1472794.8	473765.74	convex lens @ 10"	
3	50 / 8	1472797.8	474145.74	radium button @ 8"	
4	45 / 7	1472867.8	474153.74	radium button @ 10"	
5	50 / 7	1472937.8	474168.74	radium button @ 8"	
6	35 / 7	1472987.8	473991.74	radium button @ 12"	
7	30 / 8	1472564.8	474032.74	radium button @ 10"	
8	55 / 8	1472588.8	474091.74	radium button @ 12"	
9	15 / 9	1472626.8	474050.74	radium button @ 12"	
10	18 / 20	1472653.8	474009.74	plastic warning sign pieces (red) @ 8"	
11	83 / 8	1472720.8	474120.74	radium button @ 10"	
12	45 / 7	1472718.8	474115.74	radium button @ 10"	
13	135 / 11	1472703.8	474100.74	radium button @ 8"	
14	320 / 7	1472805.8	474122.74	radium button @ 6"	
15	61 / 8	1472847.8	474111.74	plastic glow dot @ 10"

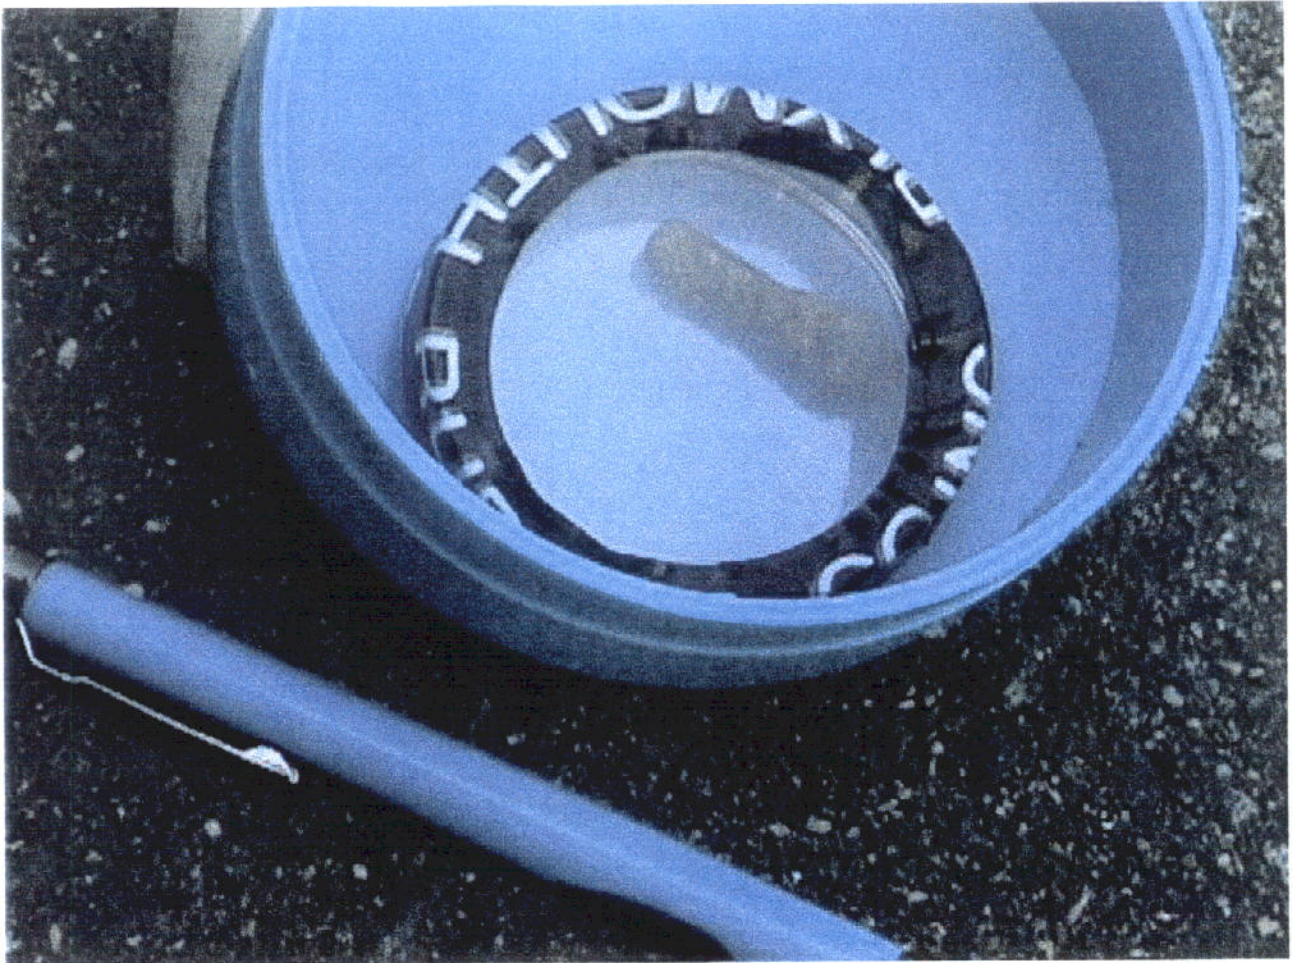
**ALAMEDA POINT LANDFILL #2
TOGGLE SWITCH LEVER
(FROM ANOMALY REMOVAL SITE #16)**

16	18 / 6	1472102.8	474164.74	1" long toggle @ 10"	
17	27 / 15	1472249.8	474266.74	5/8" rusty metal @ 12"	
18	30 / 50	1472336.8	474214.74	"terrazzo" pieces @ 12"	
19	66 / 58	1471813.8	474265.74	gageface (aluminum) @ 10"	
20	32 / 11	1471607.8	474122.74	button 3/4" @ 10"	
21	100 / 24	1471280.8	474494.74	Sound powered phone jackbox @ 10"	
22	40 / 7	1473002.8	474008.74	radium button @ 8"	
23	35 / 8	1472503.8	474266.74	melted glass & soil @ 8"	
24	130 / 8	1472499.8	474260.74	rock/metal 1/2" diameter @ 6"	
25	25 / 8	1472478.8	474260.74	rock/metal 1/8" diameter @ 4"	
26	150 / 60	1472920.8	473997.74	radium button @ 3", plastic gage cover & small "speck" @ 10"	
27	80 / 8	1472827.8	474079.74	radium button @ 6"	
28	70 / 7	1472820.8	473978.74	radium button @ 12"	
29	60 / 8	1472917.8	474006.74	strontium button @ 6"	stainless case & thick lens; "glow in dark"
30	40 / 8	1472984.8	474012.74	radium button @ 8"	@ fenceline

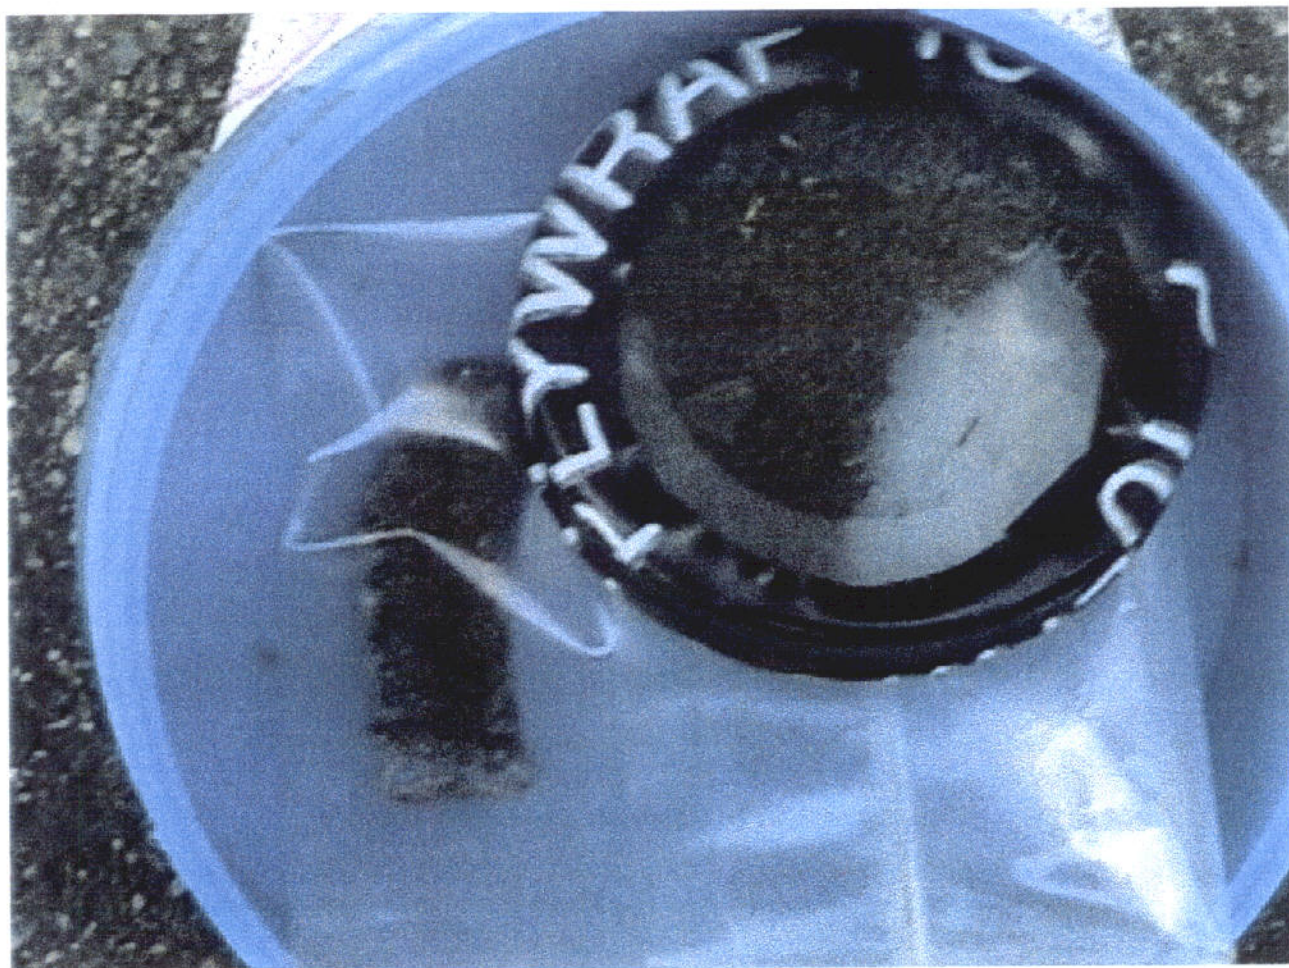
**ALAMEDA POINT LANDFILL #2
MELTED GLASS AND SOIL
(FROM ANOMALY REMOVAL SITE #23)**

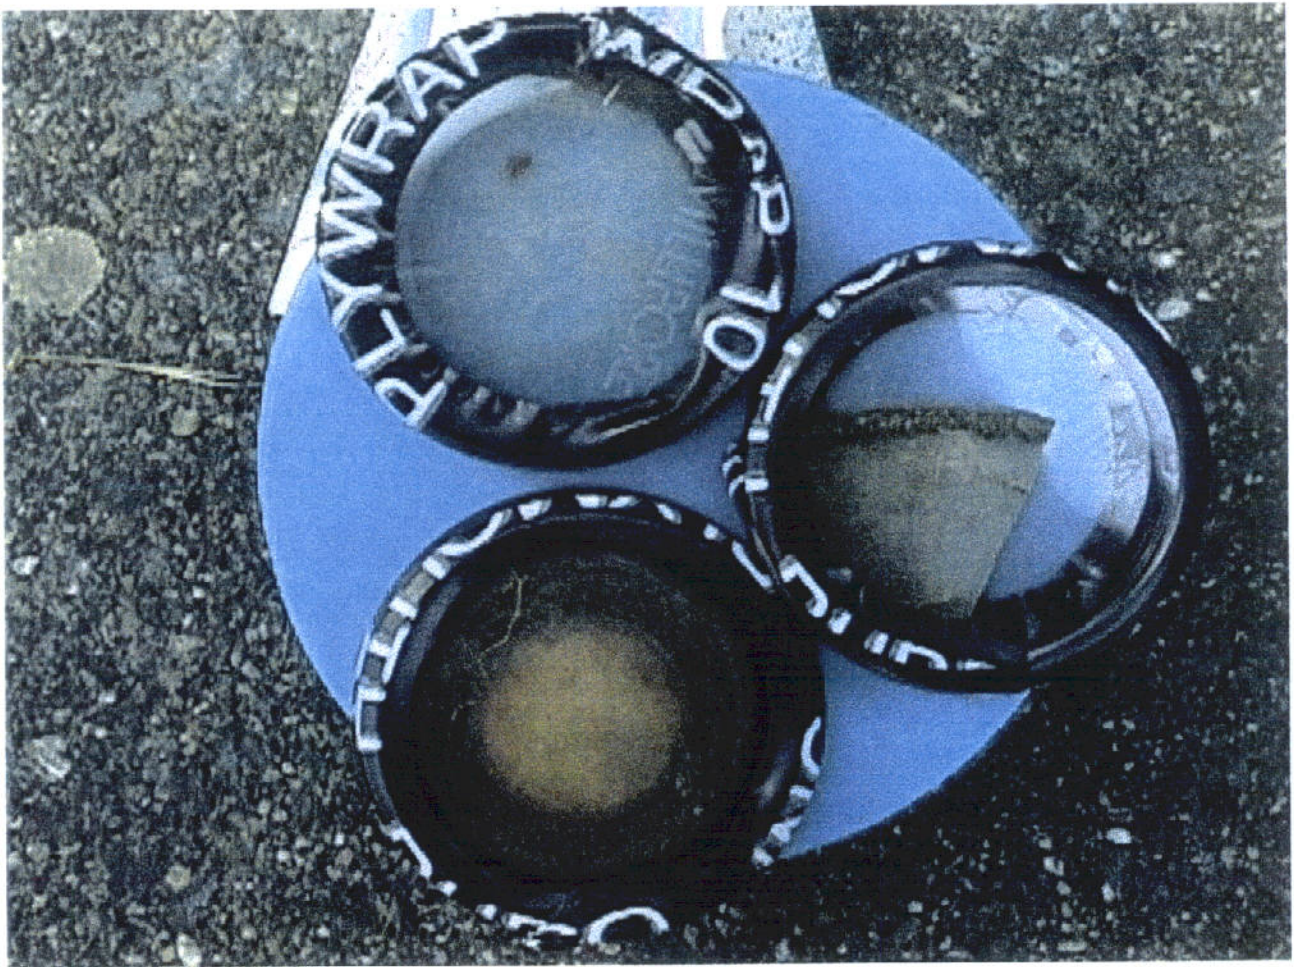
ALAMEDA POINT LANDFILL #2
TYPICAL RADIUM BUTTON AND OTHER ITEMS
(FROM ANOMALY REMOVAL SITE #26)

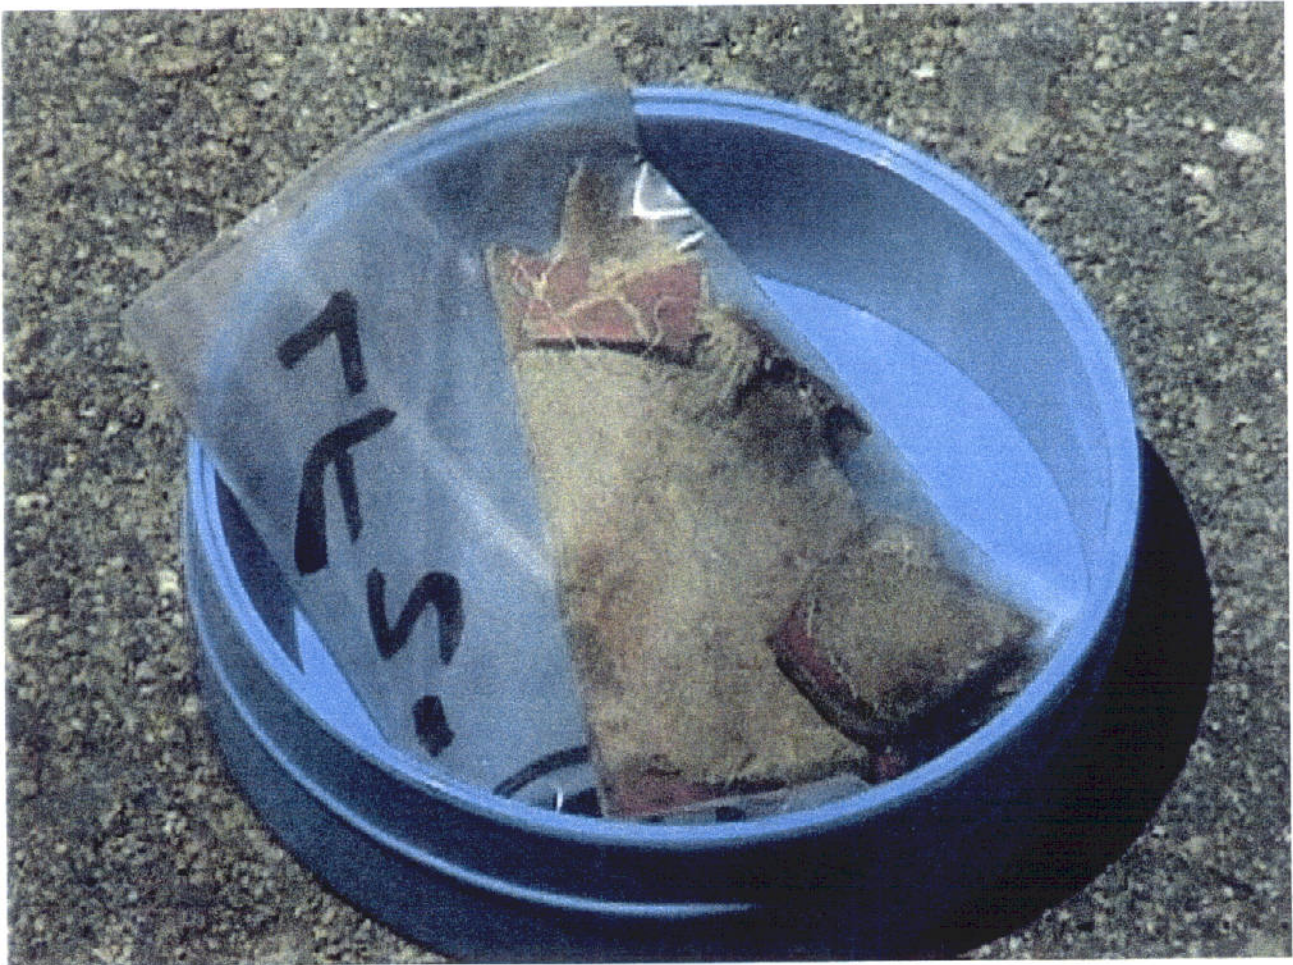
**ALAMEDA POINT LANDFILL #2
PLASTIC WARNING SIGN PIECES
(FROM ANOMALY REMOVAL SITE #10 OR 37)**

33	52 / 9	1472738.8	474111.74	radium button @ 10"	
34	55 / 9	1472705.8	474113.74	radium button @ 10"	
35	50 / 12	1471594.8	474390.74	plastic cap w/ button @ 3"	@ "radshack" site
36	15 / 8	1472575.8	473979.74	metal bracket w/ plastic knob @ 5"	
37	20 / 15	1472632.8	473958.74	plastic warning sign piece @ 8"	
38	40 / 7	1472908.8	473931.74	radium button @ 8"	
39	95 / 18	1472815.8	474110.74	plastic glow dot @ 4"	
40	15 / 8	1472920.8	474100.74	radium button @ 14"	
41	17 / 7	1471756.8	474293.74	metal chunk 1" diameter. @ 6"	
42	50 / 44	1471809.8	474359.74	rust in sand @ 4"	
43	25 / 26	1471980.8	474082.74	unidentified activity dispersed in soil	
44	22 / 9	1471587.8	474379.74	red plastic knob @ 4"	@ "radshack" site
45	63 / 7	1471888.8	474192.74	metal chunk 1/2" diameter @ 3"	
46	41 / 9	1472499.8	474298.74	melted glass vial @ 2"	possibly the other end of anomaly 23
47	27 / 13	1473000.8	474010.74	radium button @ 10"	~20 sq. ft. adj. area elevated

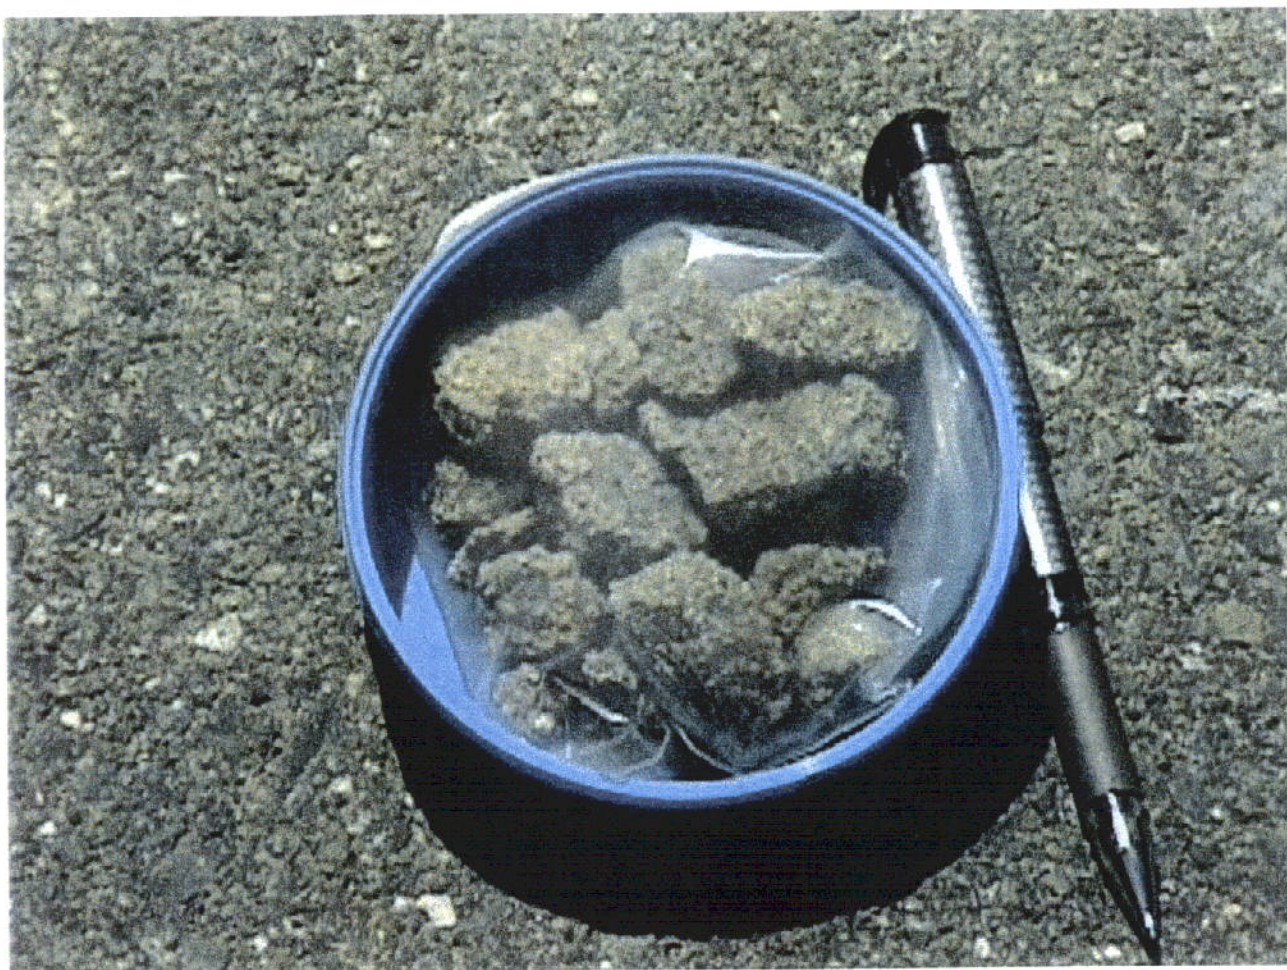
**ALAMEDA POINT LANDFILL #2
"TERRAZZO" PIECES
(FROM ANOMALY REMOVAL SITE #18)**

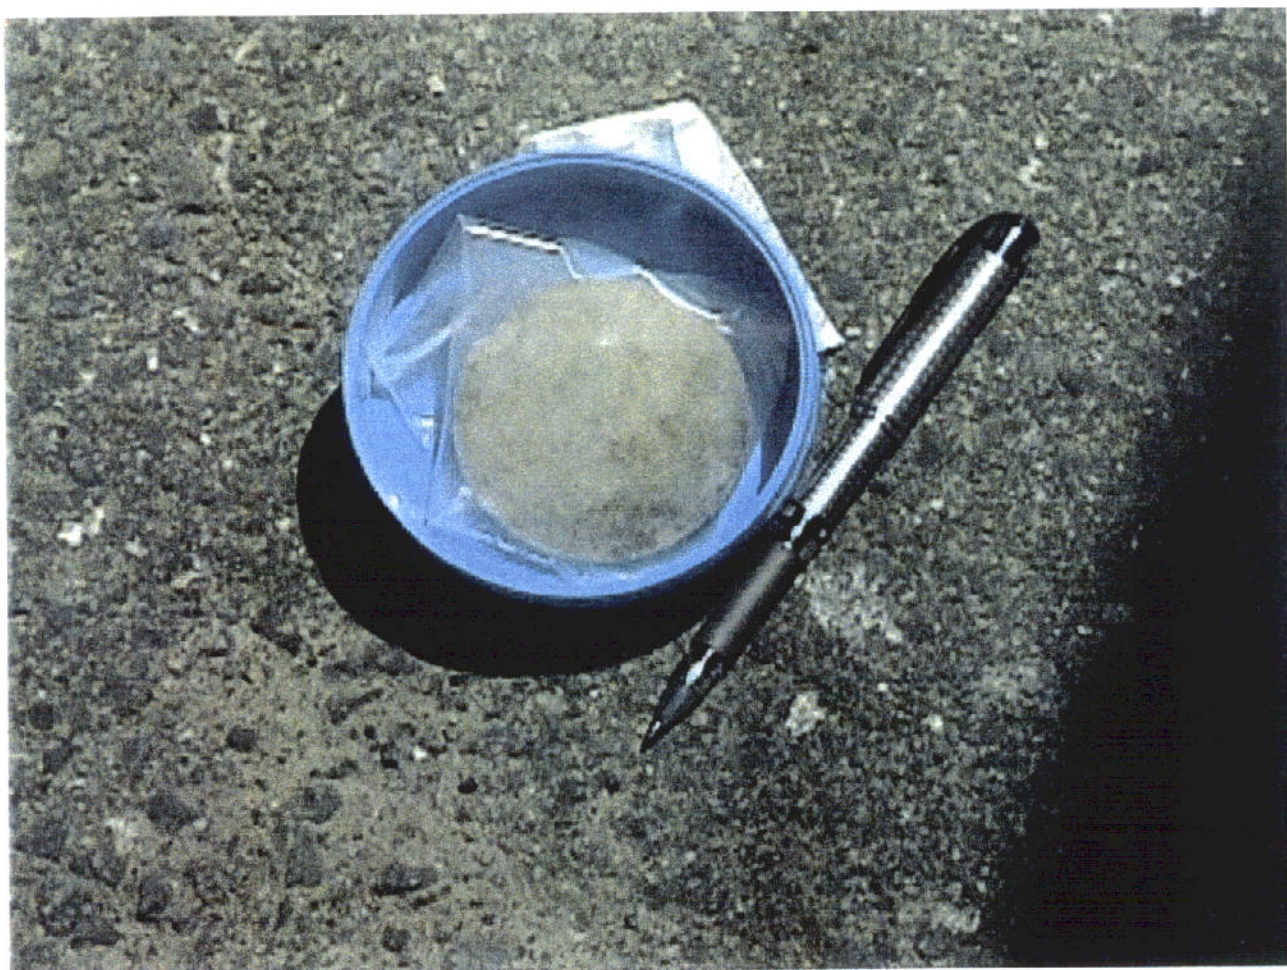
**ALAMEDA POINT LANDFILL #2
THORIATED LENS
(FROM ANOMALY REMOVAL SITE #2)**
